NASA TN D-3869

GEMINI LAND LANDING SYSTEM DEVELOPMENT PROGRAM

VOLUME I - FULL-SCALE INVESTIGATIONS

by Leland C. Norman, Jerry E. McCullough, and Jerry C. Coffey
Manned Spacecraft Center
Houston, Texas

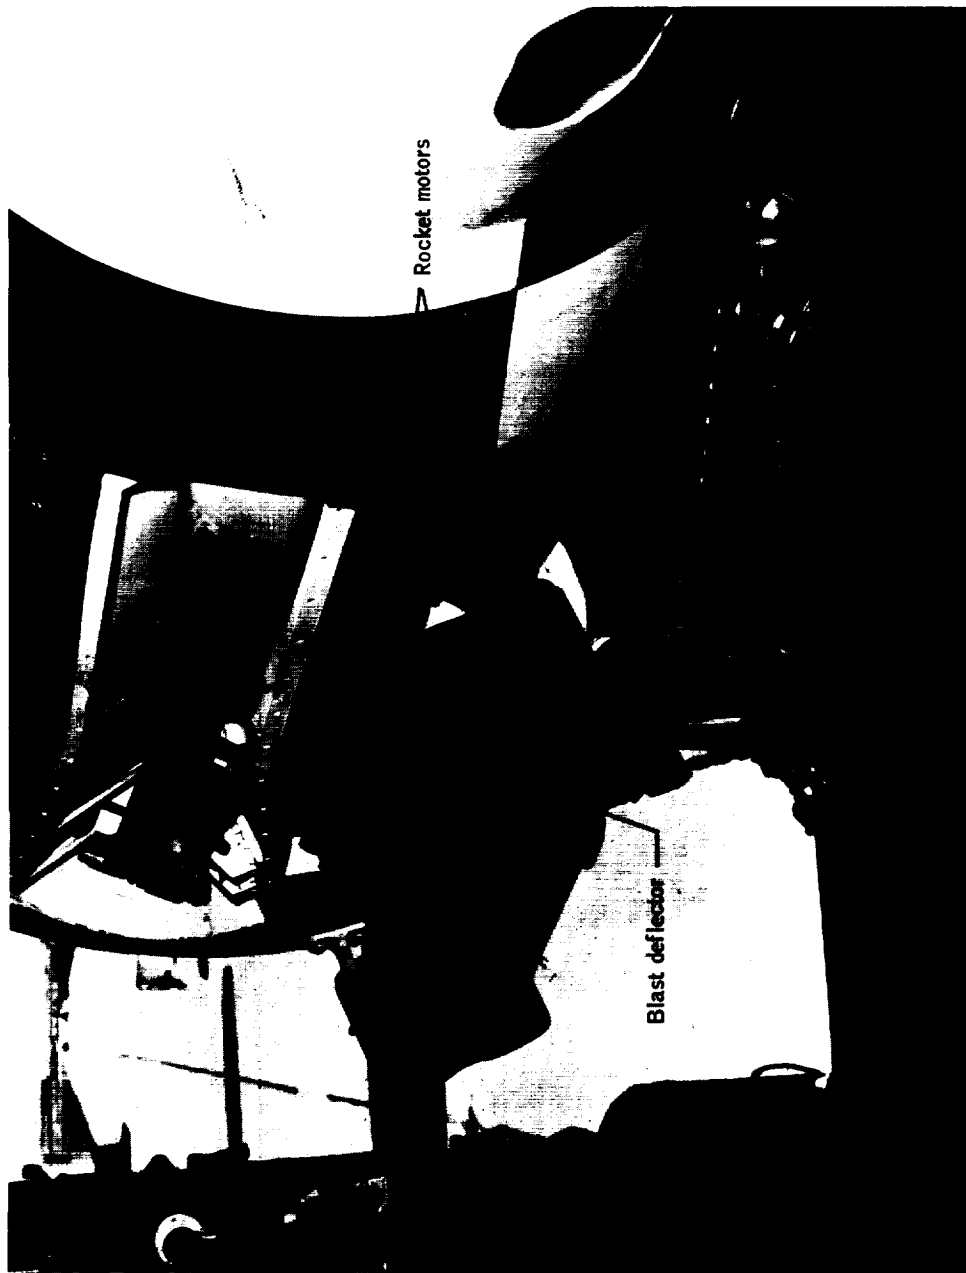
Figure 10.- Blast deflector.

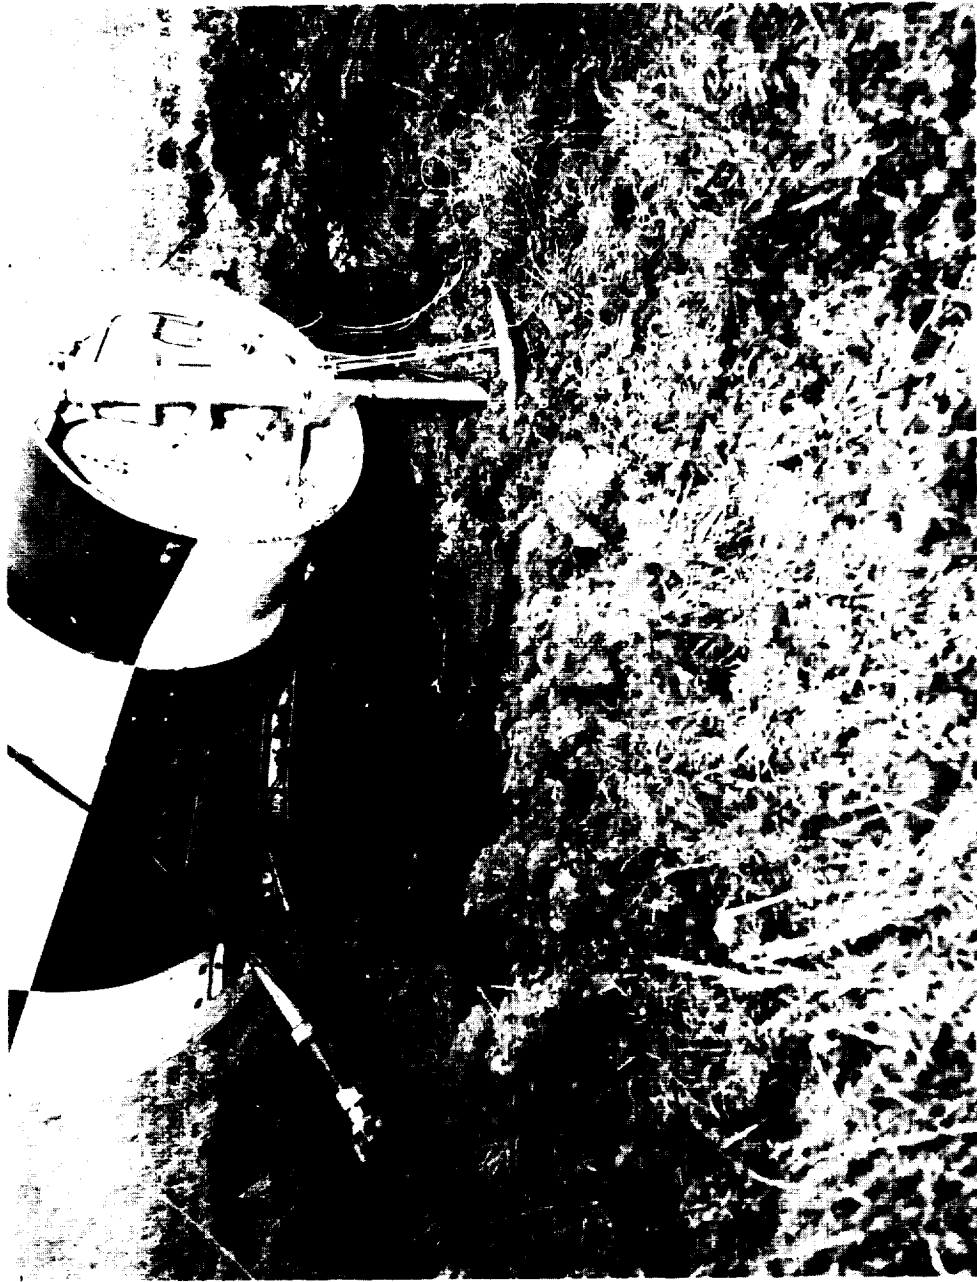
Figure 19.- Crane drop II, impact surface.

Due to the absence of horizontal velocity, this test represented the most severe landing condition from the standpoint of surface erosion (fig. 19). The dimensions of the eroded crater were 132 inches wide, 96 inches long, and 28 inches deep. The surface blew out in large chunks. This was accounted for by the high moisture content of the soil.

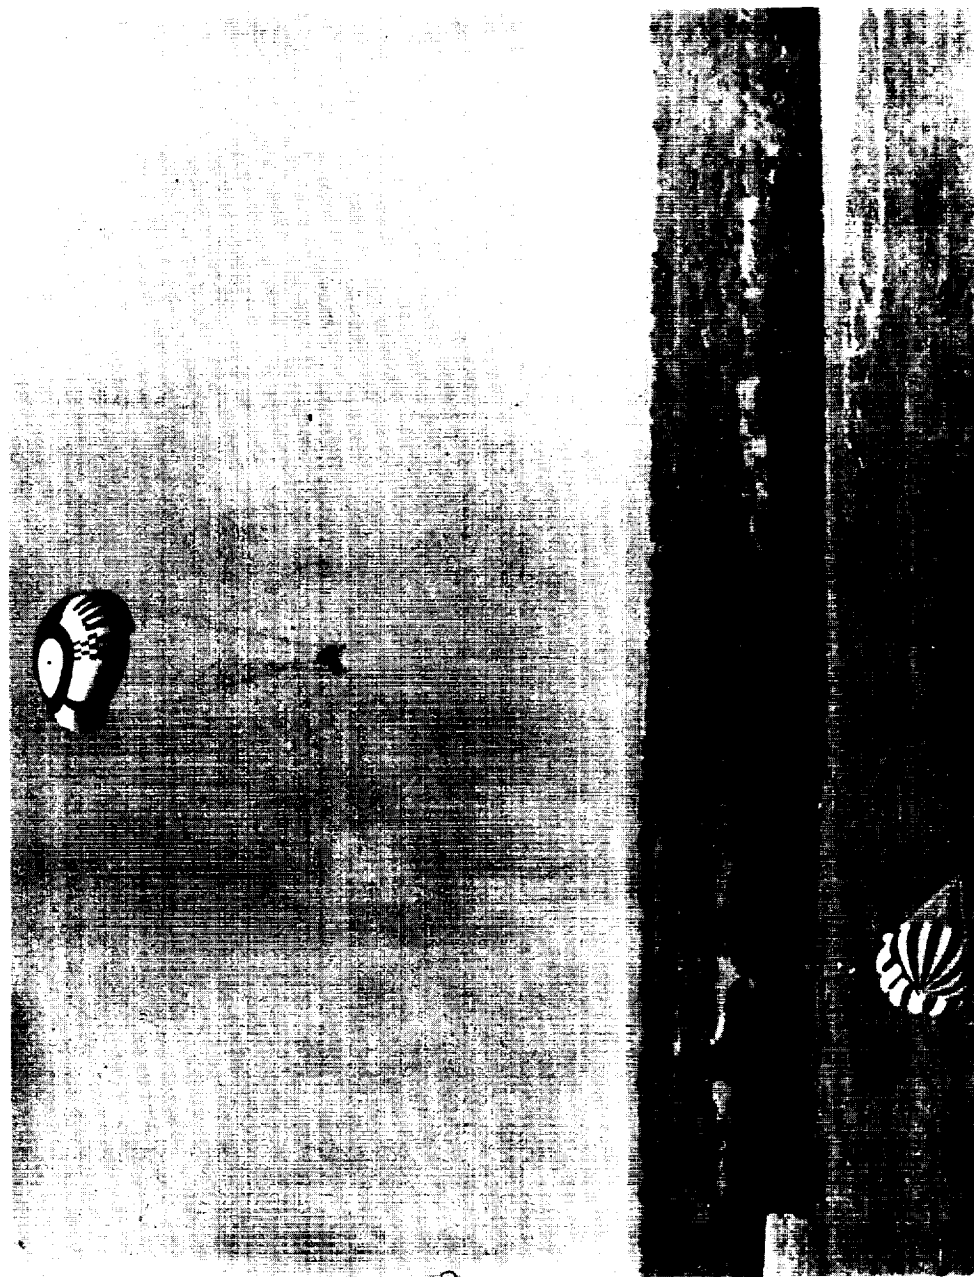
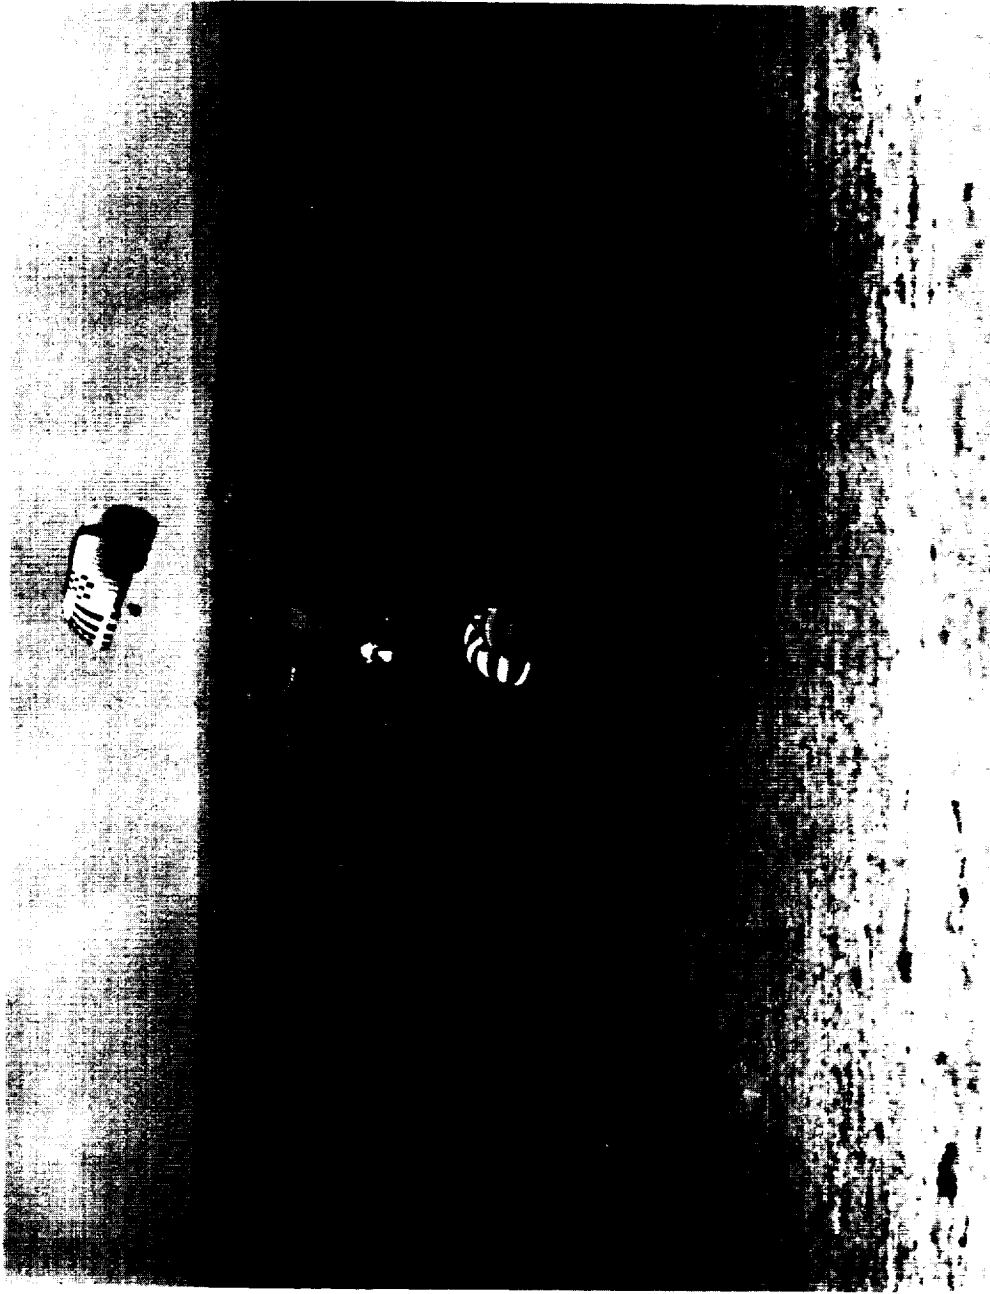
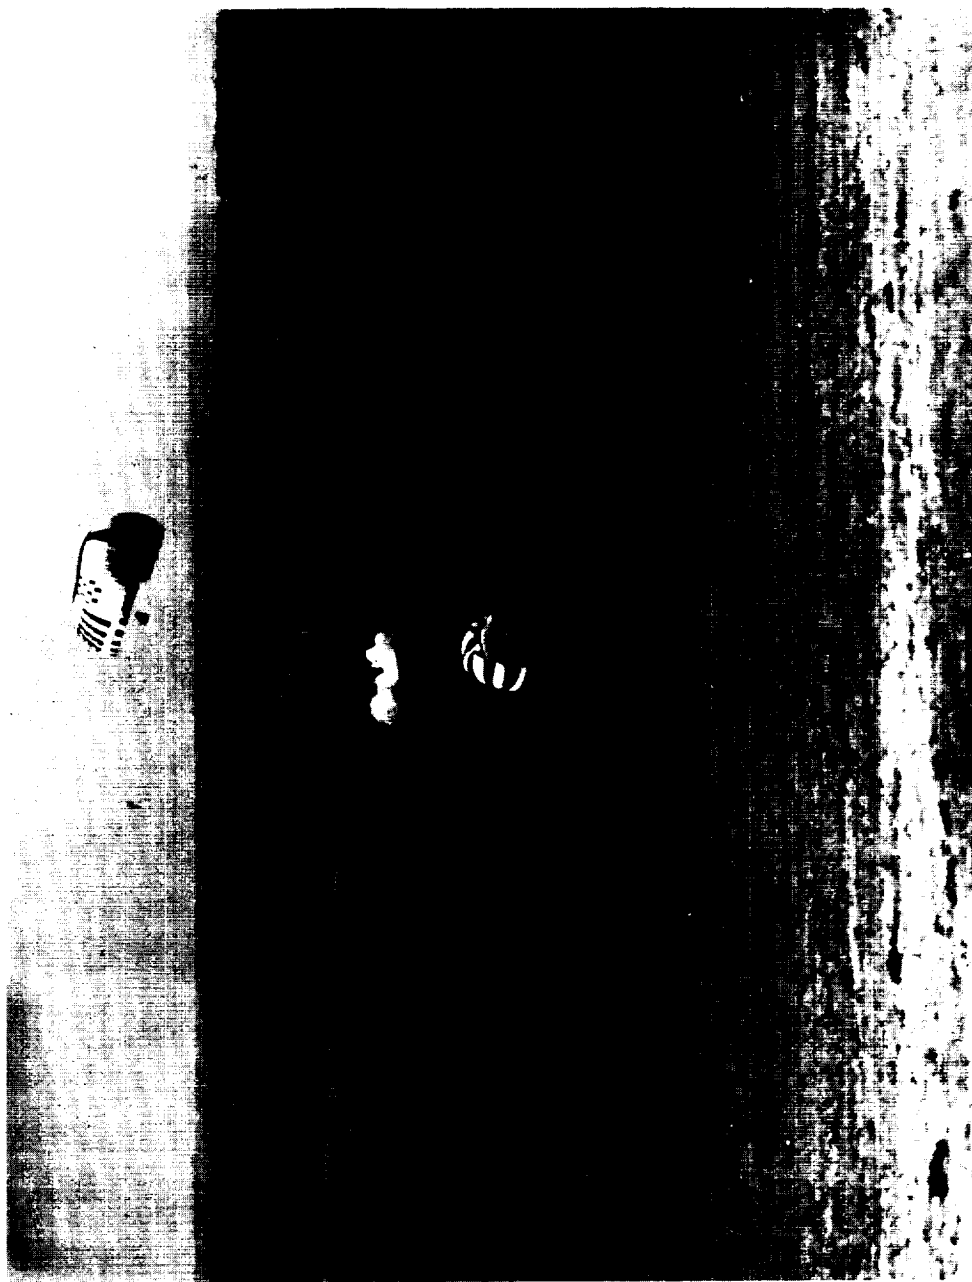
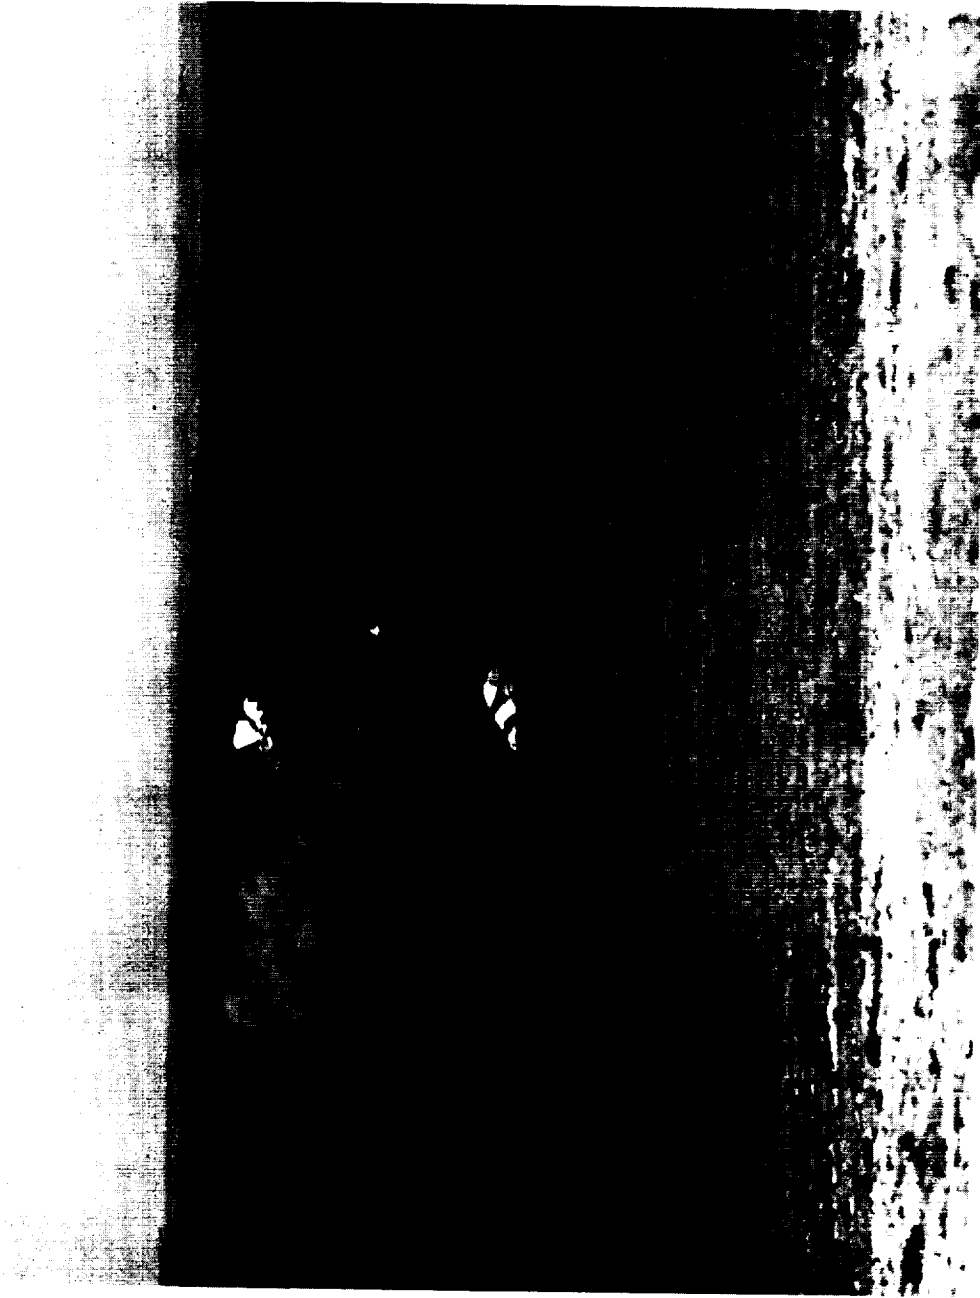
(a) Descent.
Figure 21.- Test 10.

(b) Descent .
Figure 21.- Continued .

(c) Descent .
Figure 21.- Continued .

(d) Ignition.
Figure 21.- Continued.

(e) Just prior to impact.
Figure 21.- Continued.

(f) Vehicle tumbles .
Figure 21.- Concluded .

Figures 21(a) to 21(f) depict the landing sequence. The parachute in the foreground is the blast-deflector recovery parachute, and may be used in these figures to indicate direction of ground wind. Figure 21(a) shows the system approximately 200 feet in the air. Note the bank angle indicating left turn. Also, the left-turn line is visible while the right line is missing. Figures 21(b) and 21(c) show the system in descent, just prior to impact. Note the rotation to the left. Figure 21(d) shows rocket ignition. In figure 21(e), the canopy continues to turn as the rockets fire. Note the roll angle of the test vehicle. In figure 21(f), the parachute has jettisoned, and the test vehicle has rolled on its side. Damage was limited to a sheared bracket on the nose landing gear.

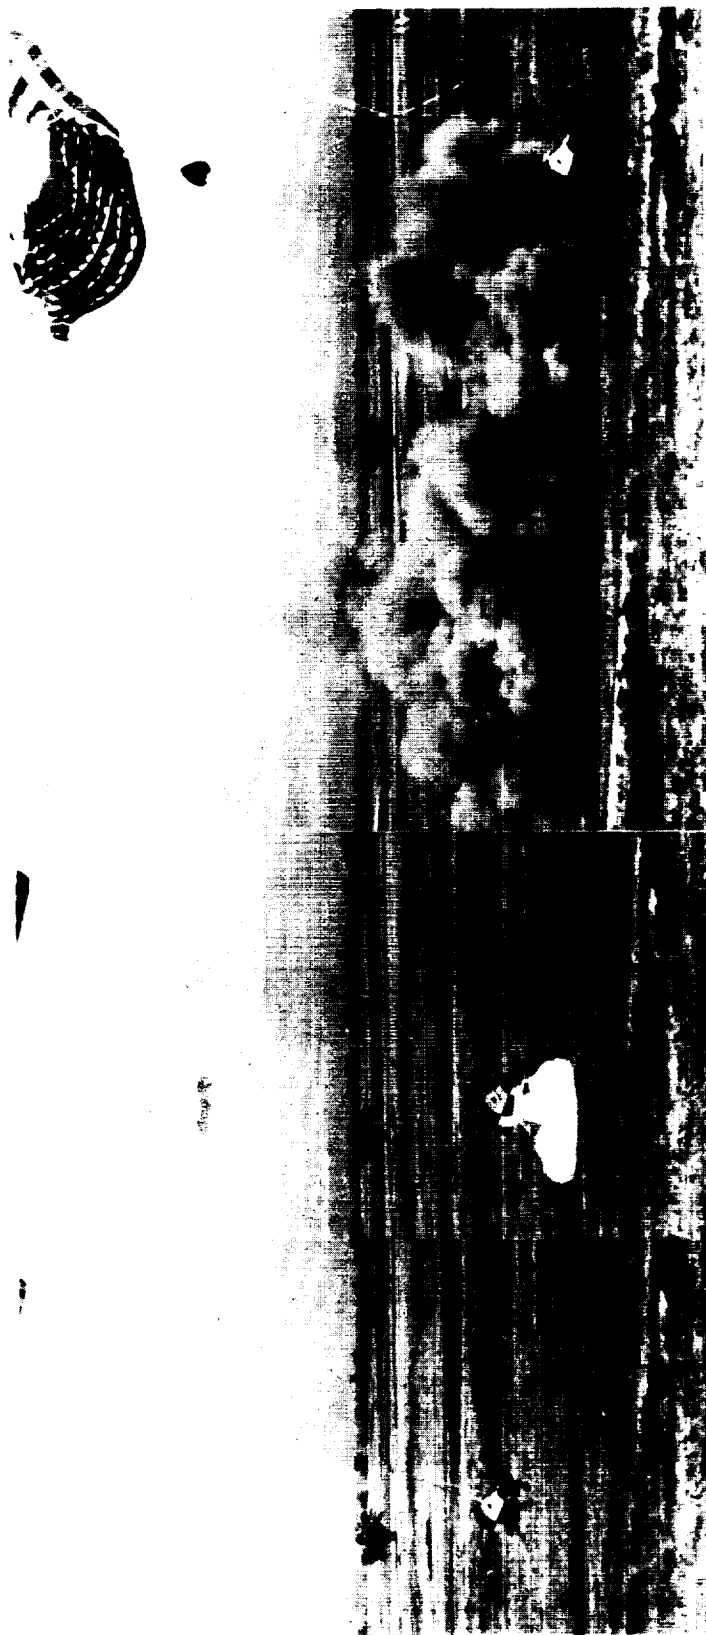
Figure 22.- Test 12, landing sequence.

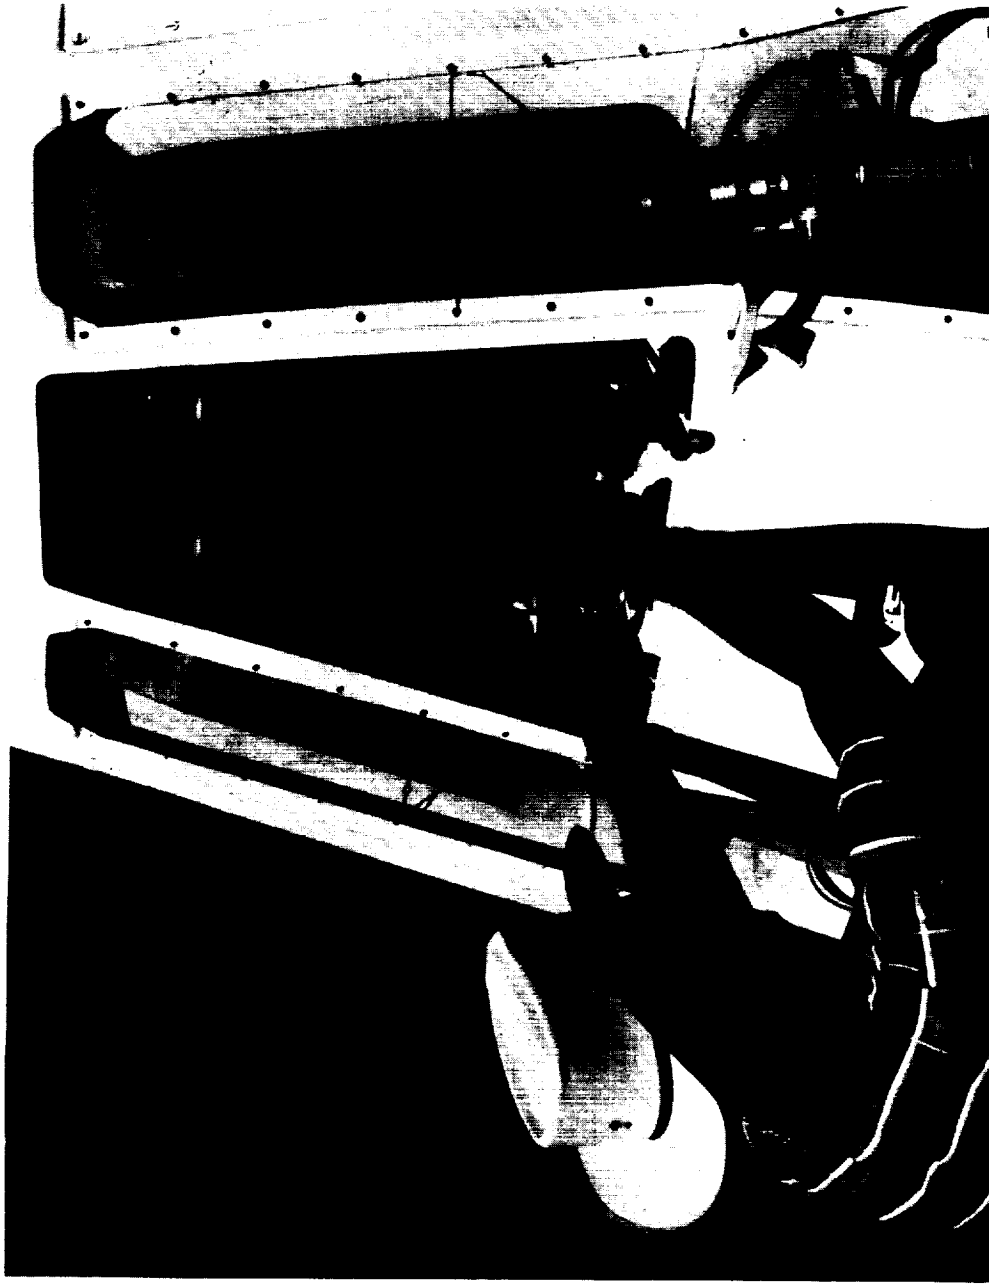
Figure 43.- Rocket alignment, exterior view.

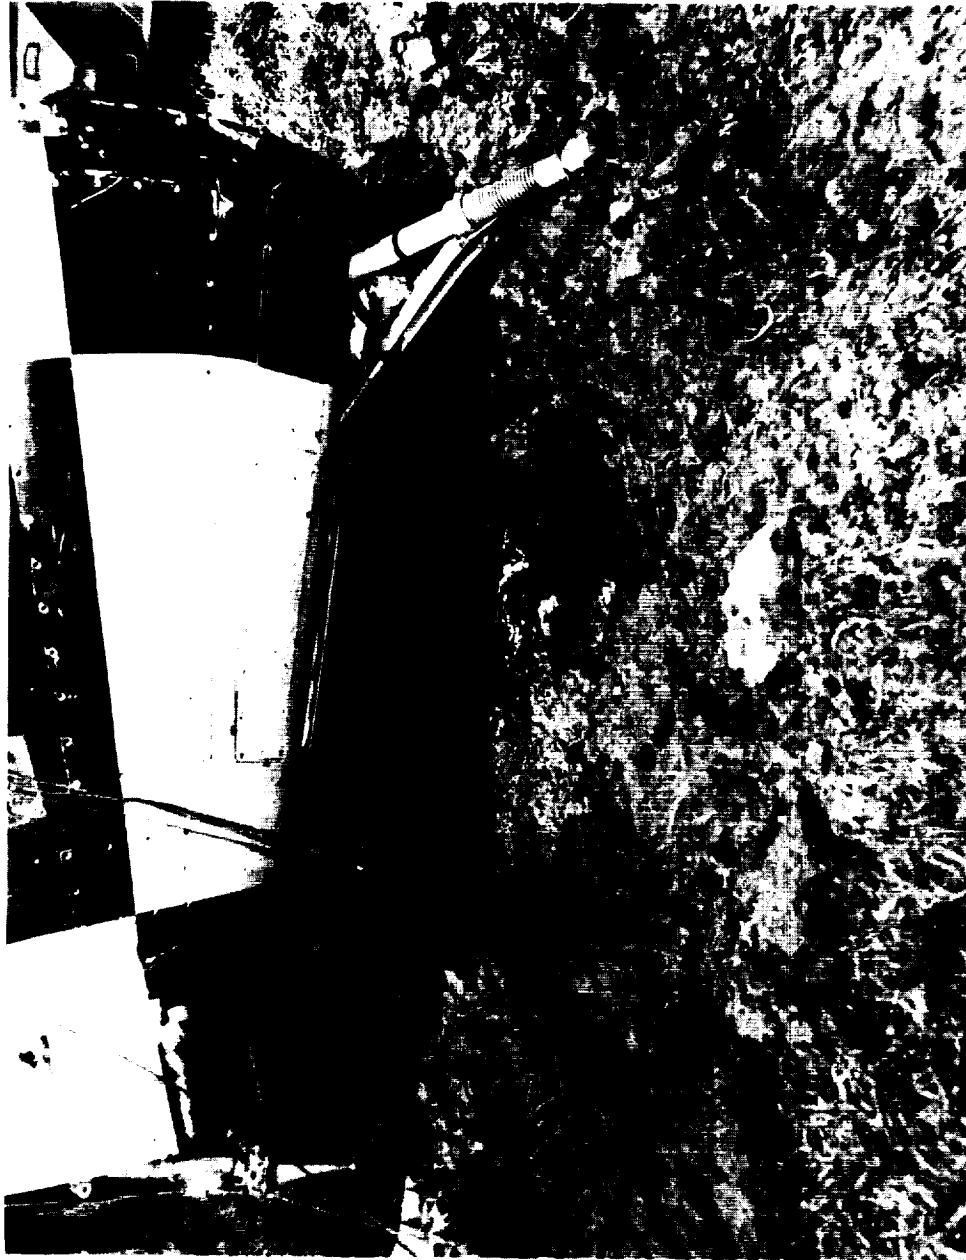
Figure 45.- Crane drop II, erosion crater.

landing rockets and landing gear was dropped from a crane to a rain-saturated sod surface. The erosion pattern closely resembled that of the first scaled-model test since the surface was explosively blown away in large chunks (approximately 1 cubic foot). The crater formed was 138 inches wide, 96 inches long, and 28 inches deep, as shown in figure 45. This amounted to a displacement of approximately 205 cubic feet of soil. No adverse stability effects were noted other than that the final attitude of the test vehicle included approximately 5° roll because the left main gear was at the end of the crater.

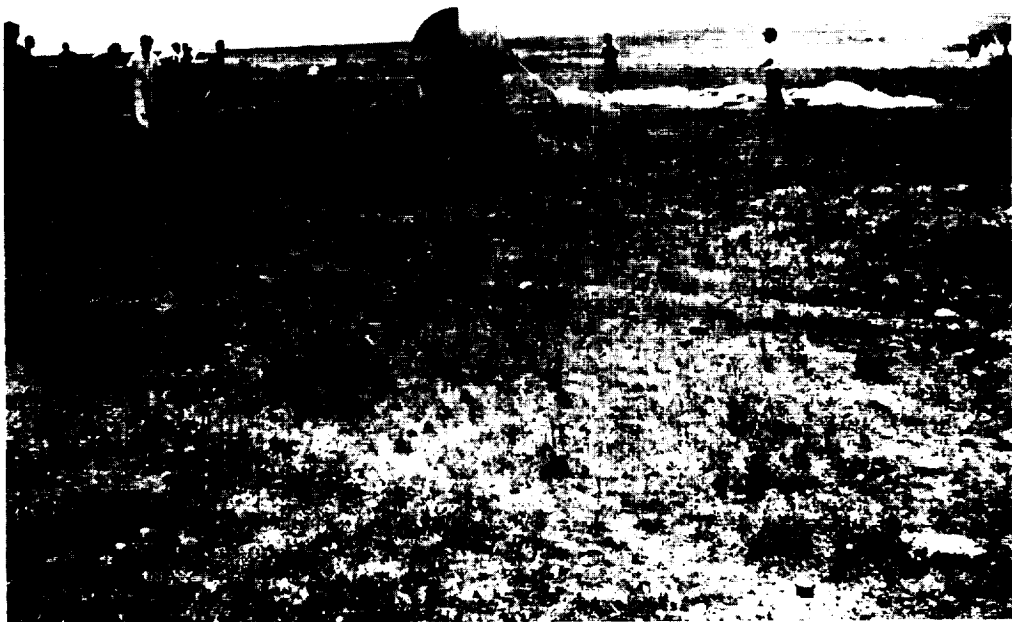
Figure 46.- Test 12, erosion path.
